TRECOM TECHNICAL REPORT 63-10

Automatic Light Aircraft Readiness Monitor

Project ALARM

VOLUME I

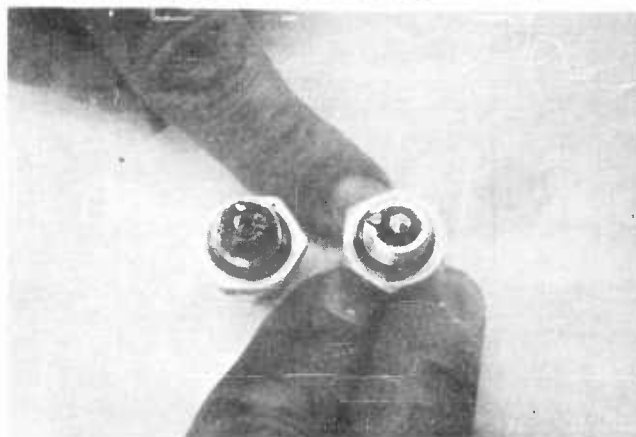
Figure 61. Relocated 42°
Gear Box And Transmission
Chip Detector Accumulations.

Following this modification the transmission was filled with clean oil. A test run was commenced without adding particles, since it was felt there would be some ferrous particles remaining in the transmission from previous tests. A chip indication occurred immediately on Channel 11, and subsequent inspection revealed the condition seen in Figure 61 (detector on the right side). The two detectors (42^O GB and Xmsn) are shown together in this photograph because both relocation tests had been conducted concurrently.

Investigation was begun to relocate the detector, similar to that performed on the 42^O Gear Box (see Test #15). In order to avoid a structural modification of the Xmsn Sump Case, it was decided to place the detector in the drain opening. This placed the sensor flush with the sump bottom just beneath the pump intake screen (see Figure 71). It was also decided to utilize a smaller detector with a 0.060-inch gap in place of the previous detector which had a gap width of 0.100 inch. The detector from the 42^O Gear Box was adapted to fit into sump drain opening.

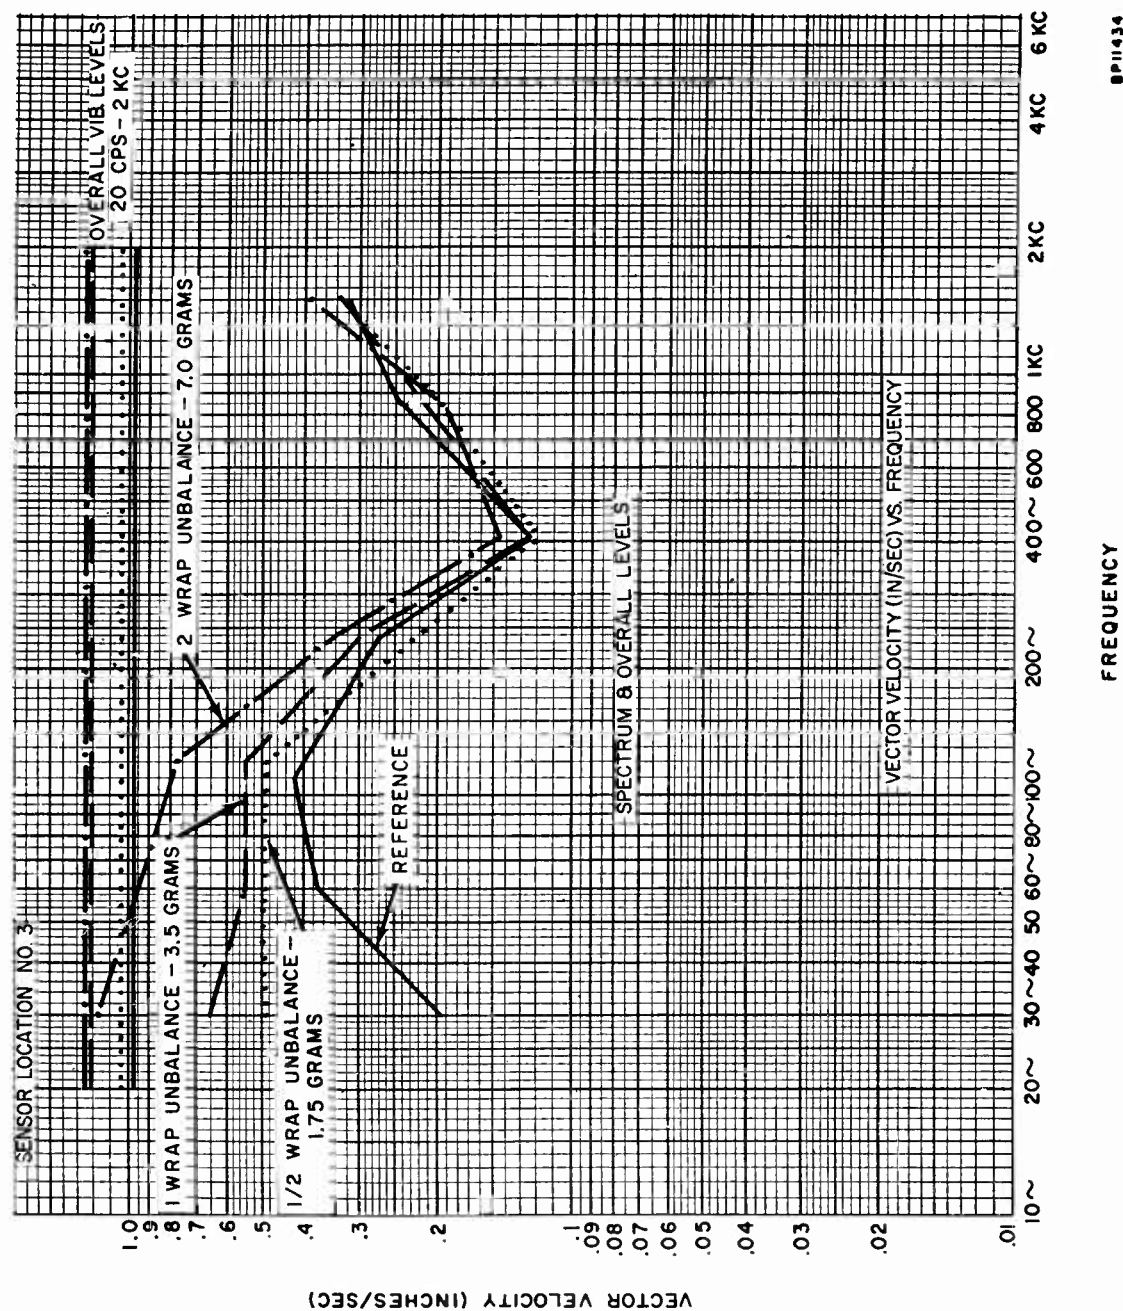
FIGURE 62. TAIL VIBRATION T/R UNBALANCE TESTS

Test conditions consisted of placing successive wraps of 2-inch masking tape about 4 inches from one blade tip and evaluating the resultant vibrational effect. These results are shown in Figure 62 in comparison with reference or balanced condition. "NO GO" indications were obtained for both 1 and 2 wraps. The pilot began to notice high-frequency vibrations in the pedals with two wraps, which support the main objective of the channel, that of being capable of sensing tail vibrations better than the present method of "feel". The channel also detected the 1/2 wrap condition (1.75 grams), but this would have to be considered a marginal sensitivity setting which may cause erroneous indications if set this close to the normal vibration level.

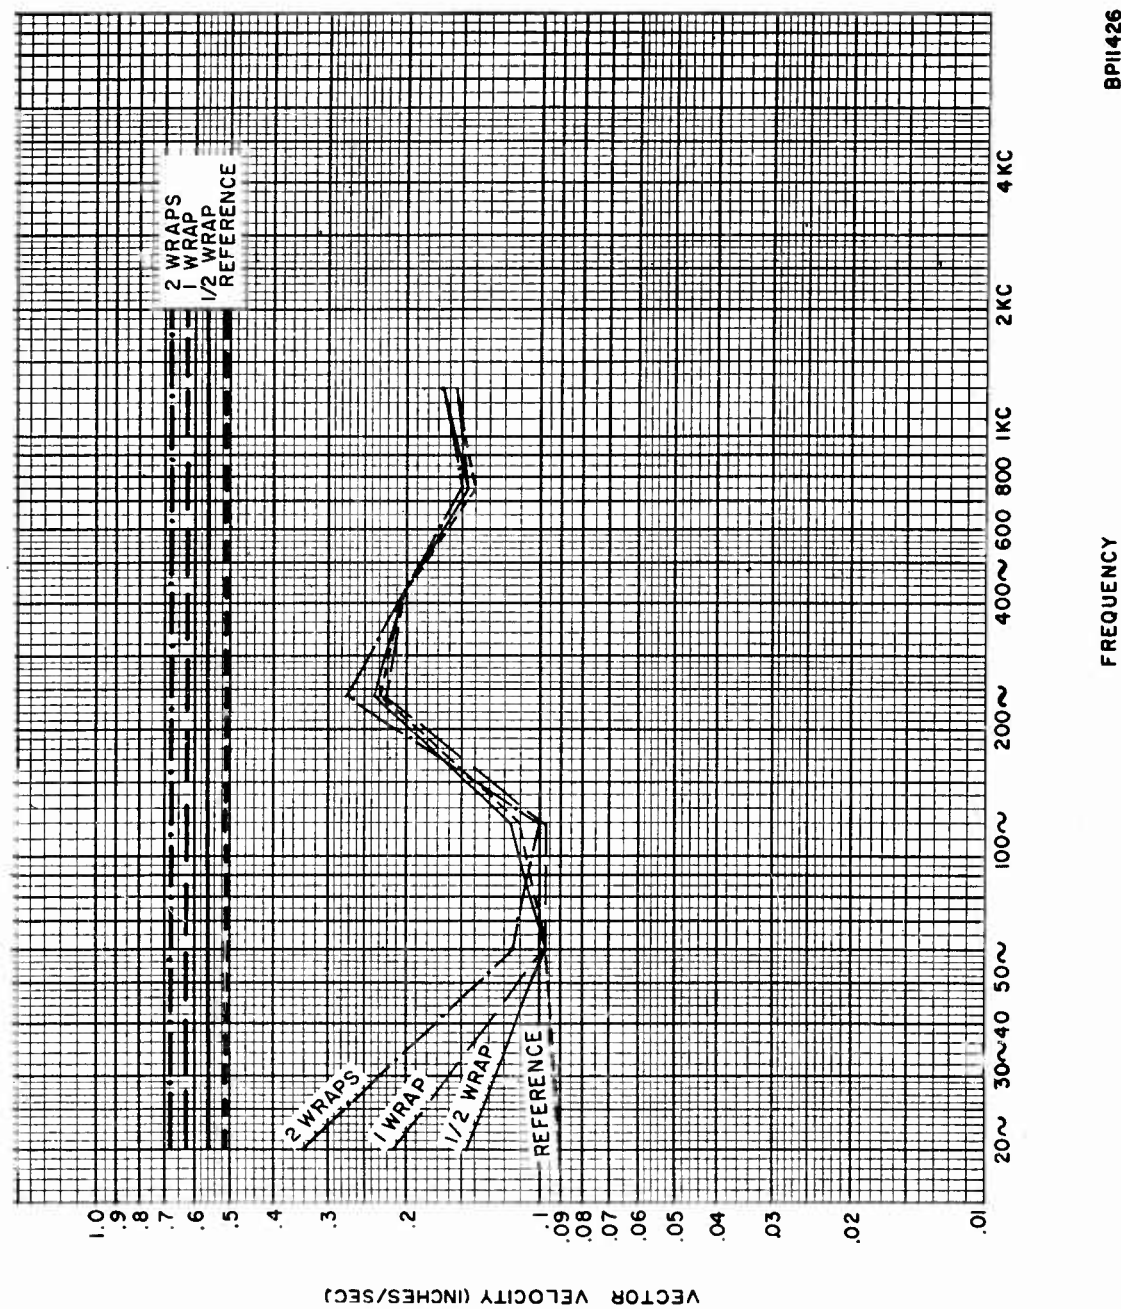
FIGURE 63. AFT ENGINE VIBRATION EFFECT OF T/R UNBALANCE

During these tests it was noticed that the Aft Engine Vibration Channel was indicating "NO GO" with tail rotor unbalances. An analysis of this effect was made, and is shown on Figure 63. The vibration of the tail section under these conditions was being propagated through the structure and influencing the engine area. All were predominantly tail rotor 1/rev influence below 100 cps as shown in the graph. Modification has been made to the Aft Engine Vibration Channel, restricting its frequency response to above 100 cycles to eliminate this undesirable interaction.

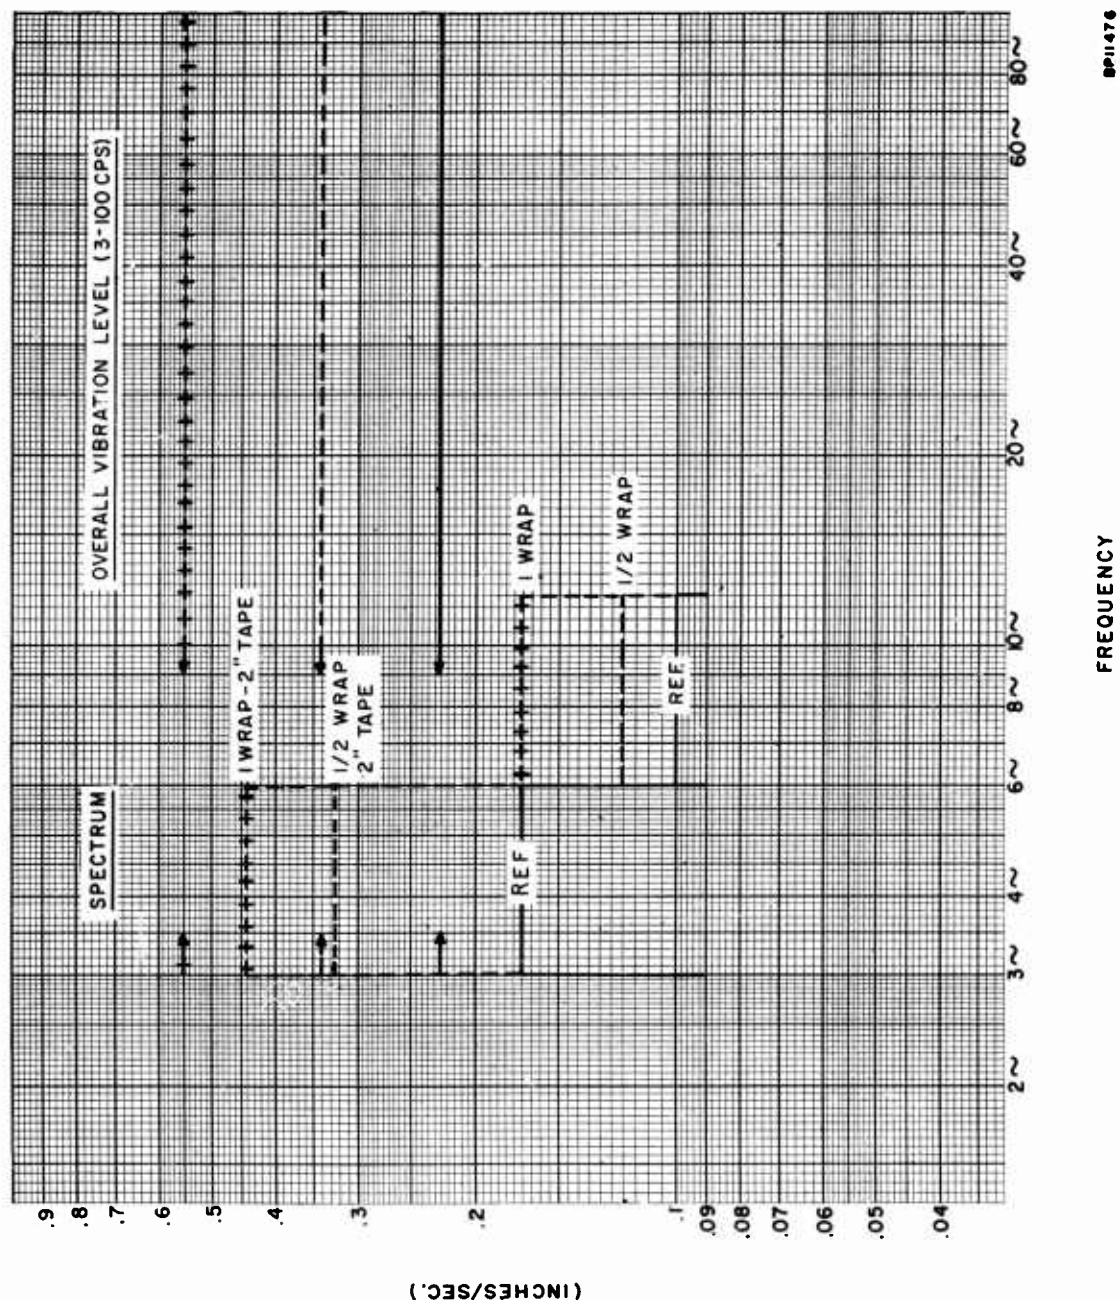
FIGURE 64. LOW FREQUENCY MAST VIBRATION, MAIN ROTOR OUT OF TRACK (PART 2)

Figure 64, Part 2 illustrates the results of deliberate introduction of main rotor out-of-track conditions as created by the indicated adjustment of one pitch change link (PCL). With one flat adjustment, essentially the same effect is created as by 1/2 wrap of tape for unbalance; (Test #17) a "NO GO" condition was indicated by Channel 26 (Low-Frequency Vibration) but no increase in cockpit vibration was noted. More than one flat out of adjustment causes noticeable vibrations in the cockpit area.

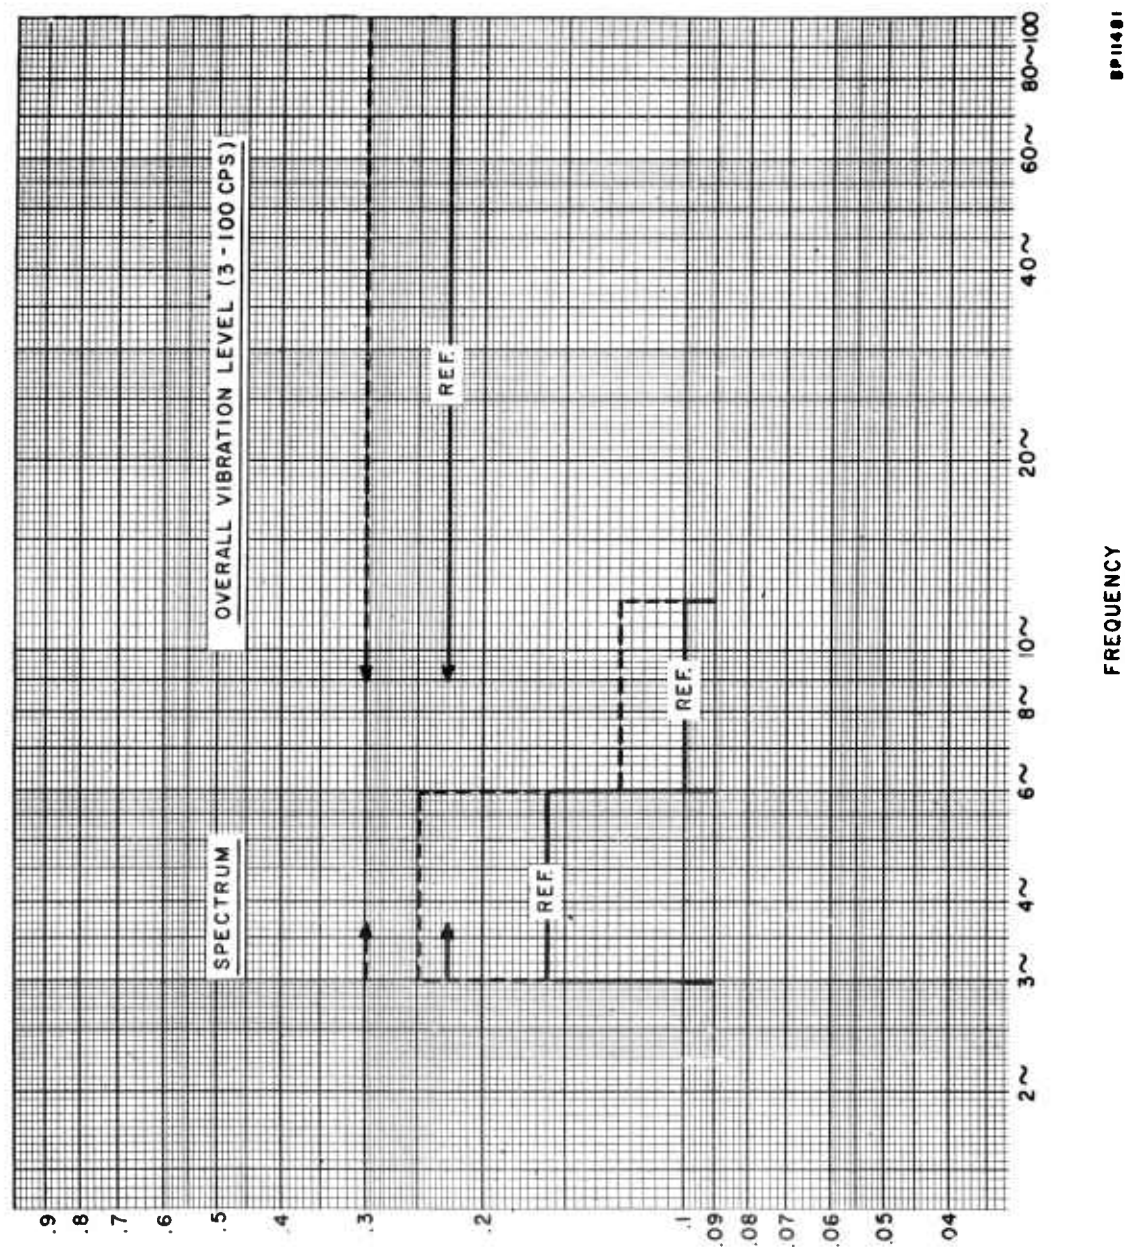
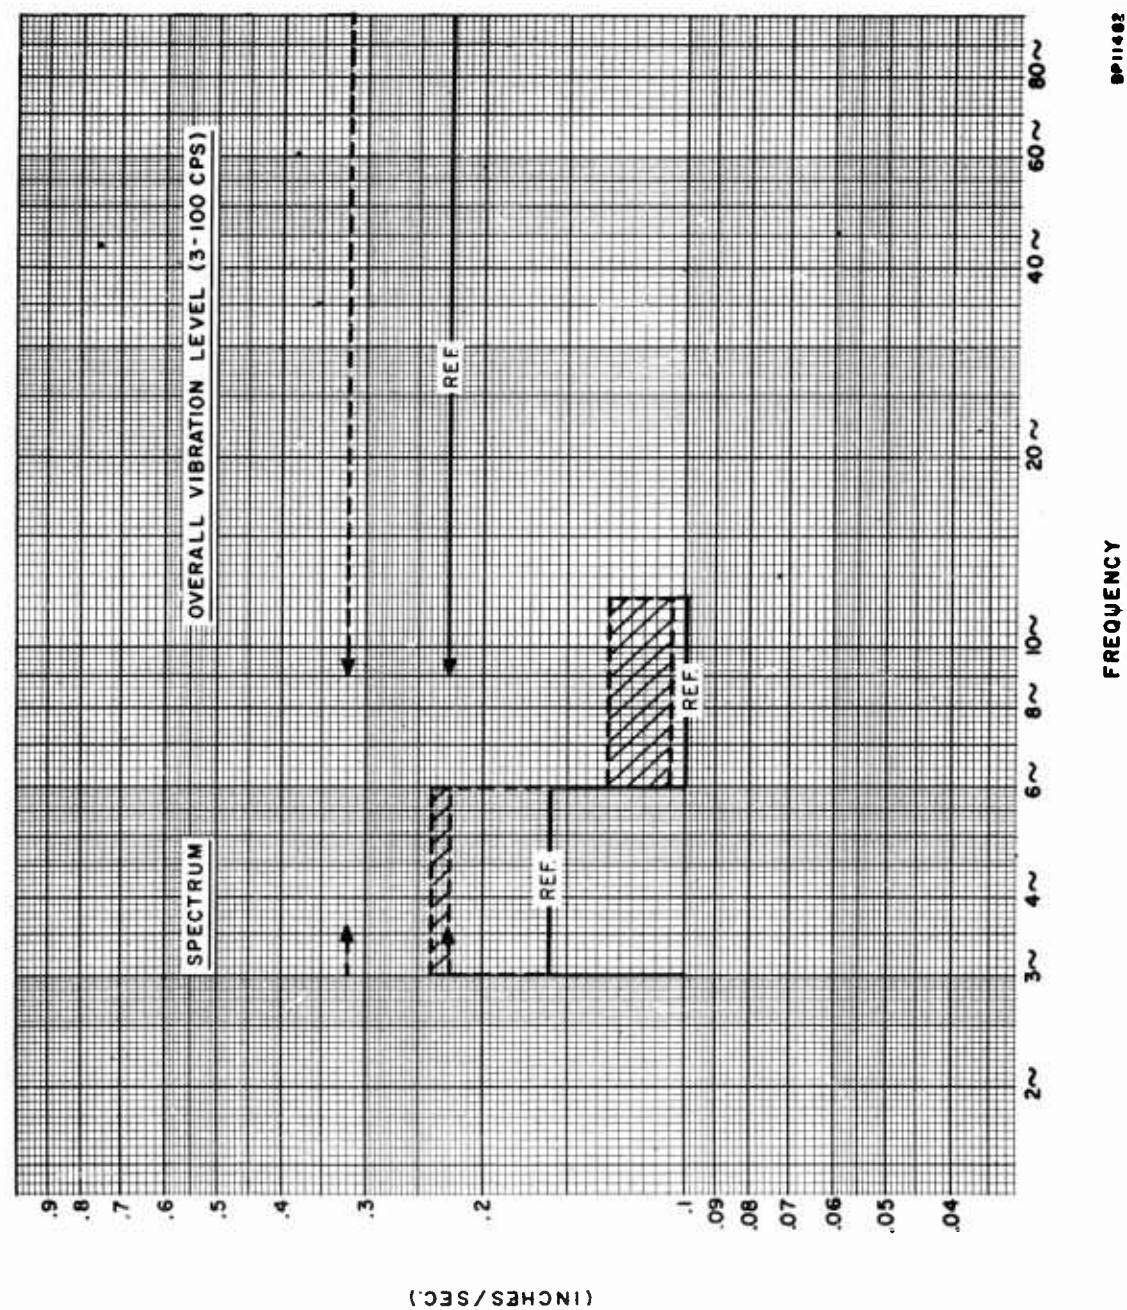
Additional observations made on the channel included those presented in Figure 65. Part 1 shows the effect of an uncentered cyclic control during 6400 rpm ground run operation, indicated as "NO GO" on the channel. This is not an abnormal condition in the main rotor, but does show an improper reference condition which should be recognized and corrected by centering the control before using this channel as the indication of an unbalance or out-of-track condition. Figure 65, Part 2, plots the results from an over-tight main rotor tie-down over a 2-day period which caused a "set" condition in the blade and subsequent 1/rev vibrations which were detected by the channel. A brief period of ground-run operation cleared this condition and the channel indicated "GO".

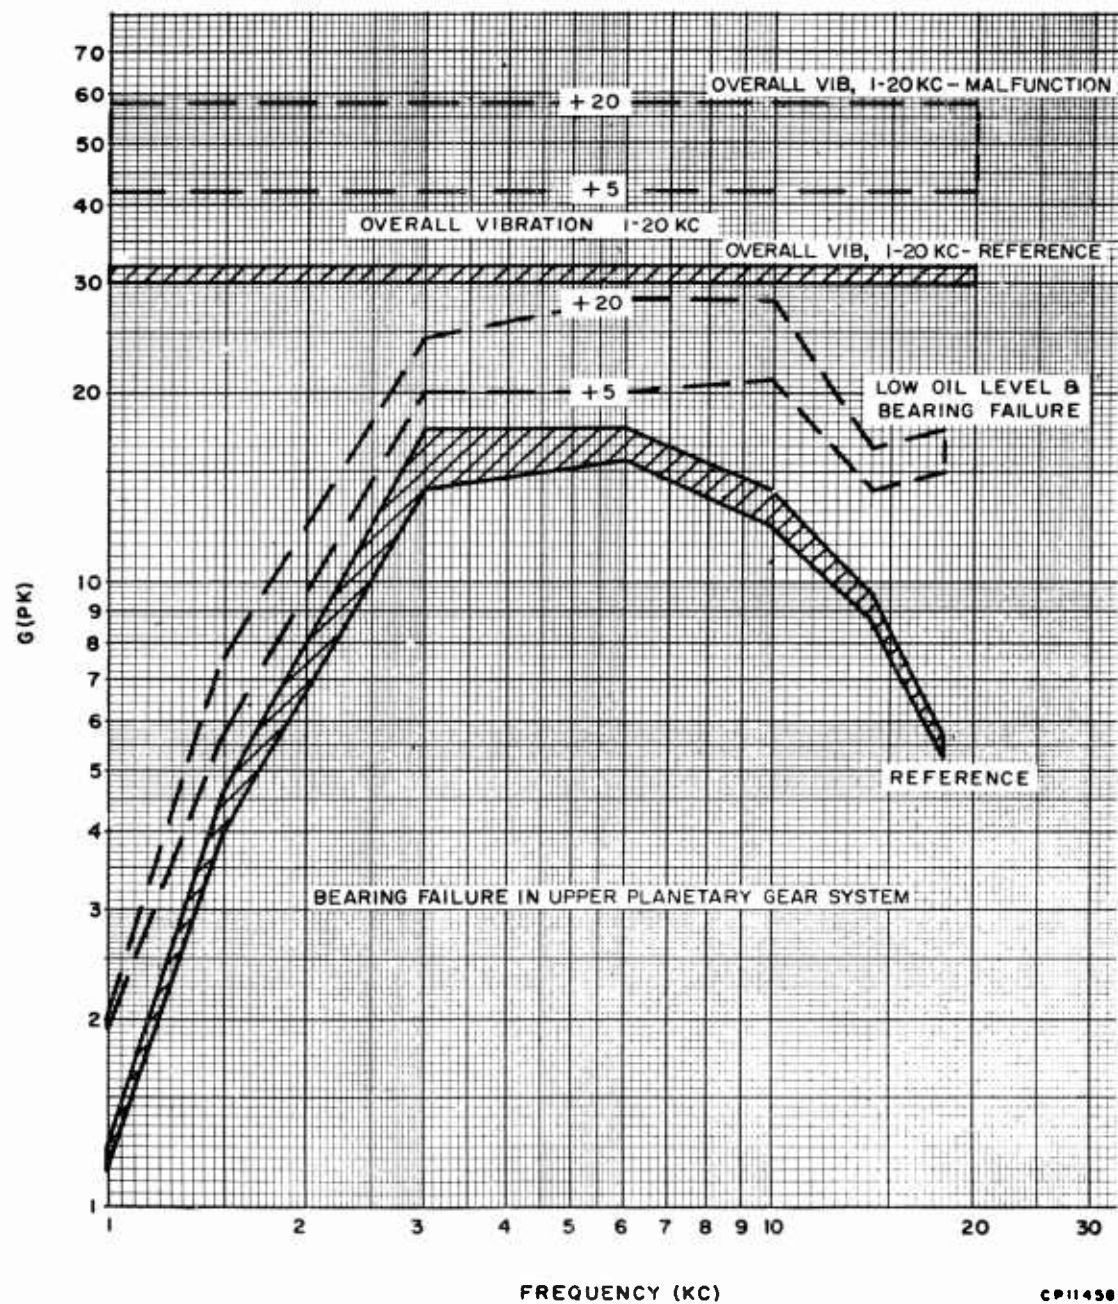
FIGURE 69. XMSN TOP VIBRATION

- Determination of detection levels in the cases of large and distinct changes between normal and malfunction operation become simply an adjustment to a detection level between the normal and malfunction range. This condition is shown in Figure 69. The detection level in this case would be set at approximately 35 g, over-all. At a particular frequency of 5 KC, a simulated input g level would be approximately 18.0 g. At 10KC the simulated input level would drop to approximately 15.2 g.

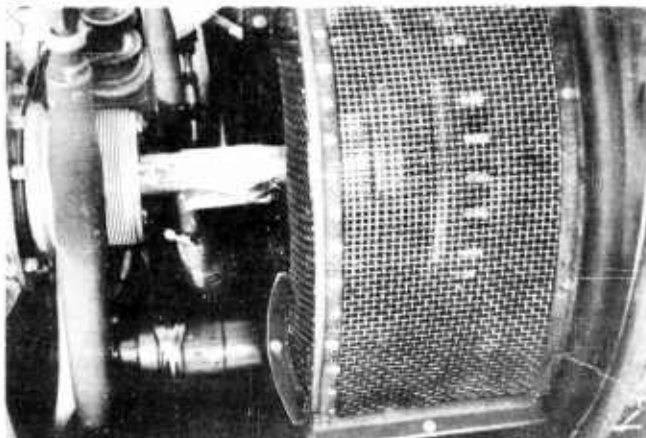
Figure 72. Method Of
Providing Short Shaft
Unbalance.

In order to examine where and how shaft-created vibrations might occur, a 20-gram metal weight was attached to the shaft by aluminum tape as shown in Figure 72. During the test run which followed, the Aft Engine Channel indicated "NO GO" consistently and the Fwd Engine Channel intermittently. Figure 73, Part 1 and Part 2, presents the data recorded for this condition.

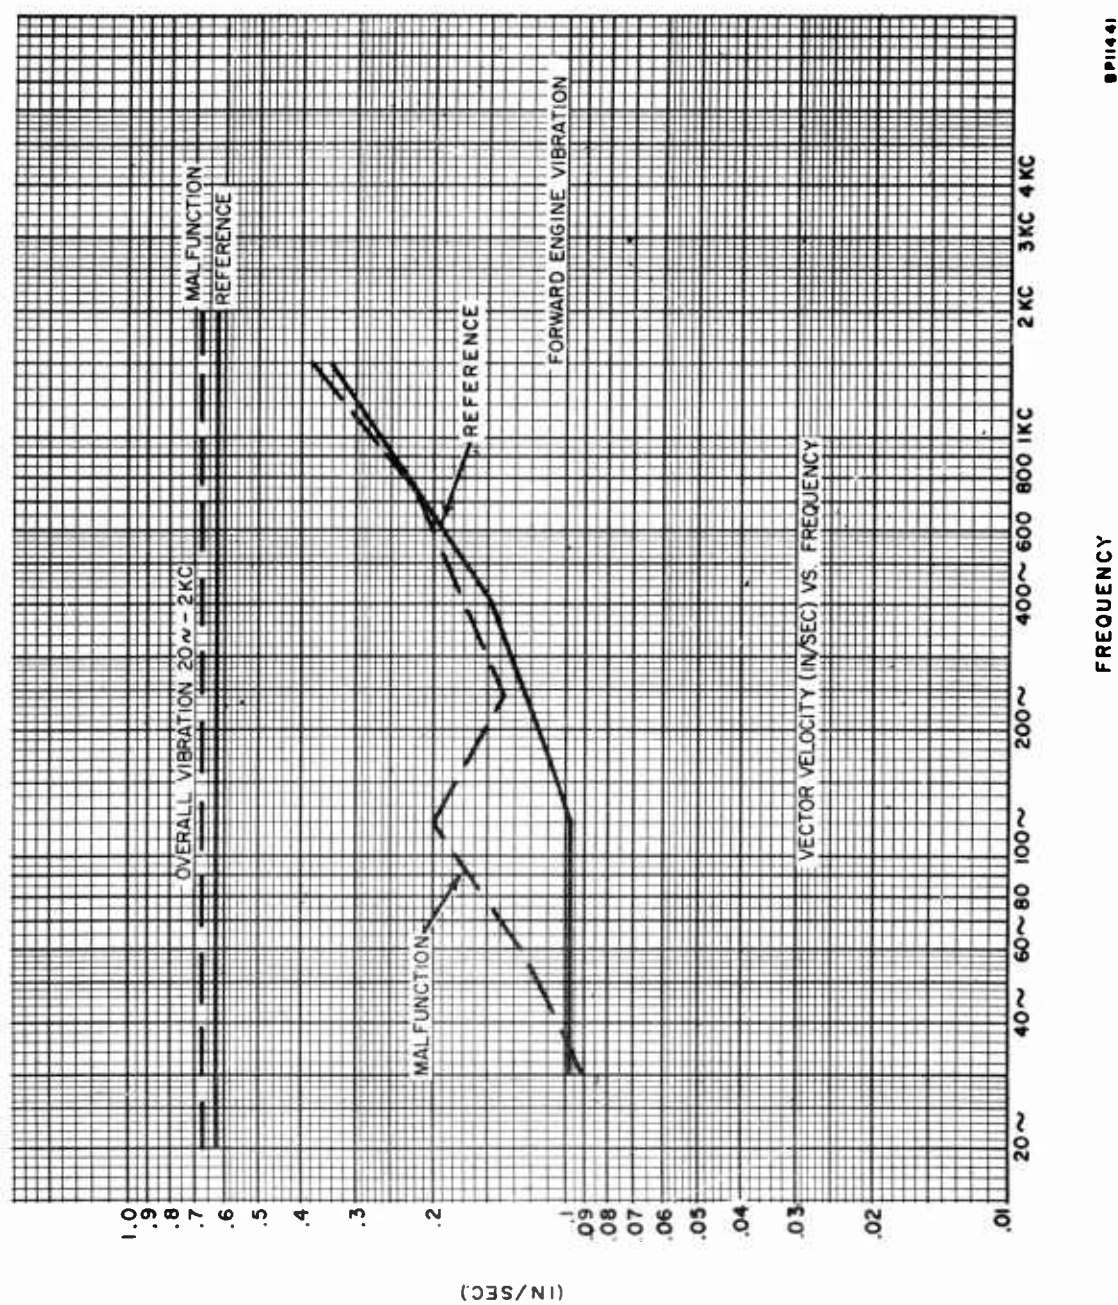
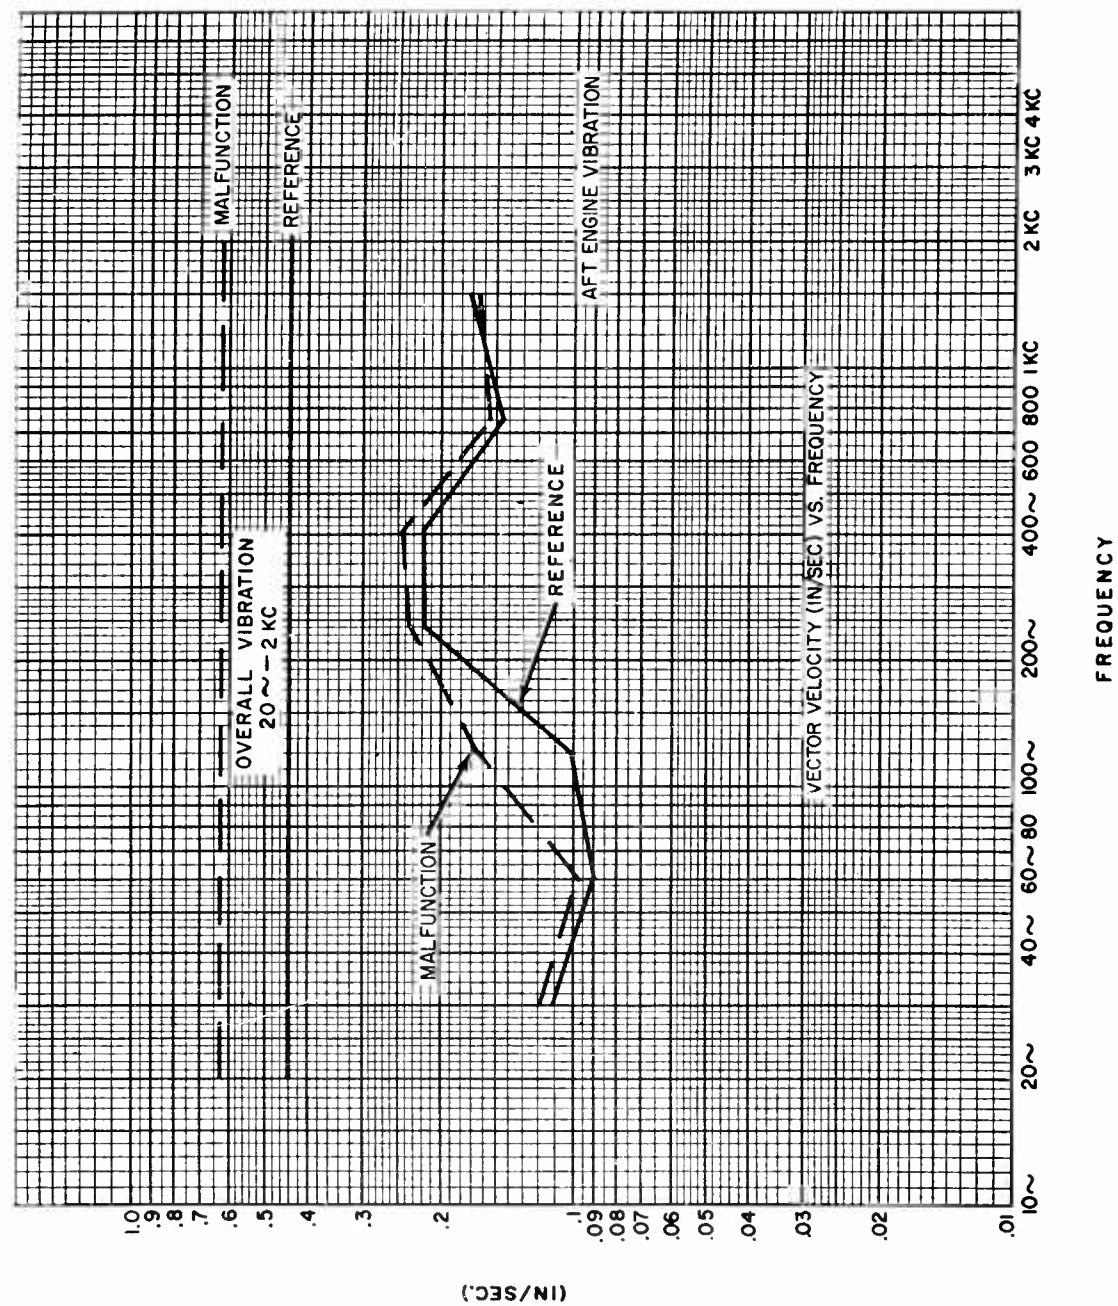
It will be recalled from previous discussions (see Test #16) that the Aft Engine Channel response had been limited to above 100 cps due to effects of tail vibrations. This, fortunately, still permits the type of vibration created by short shaft unbalance to be accepted, since the fundamental frequency is about 106 cps. Figure 73 shows the largest increase at 120 cps because the reading taken was through the filter set to accept the range of 60-120 cps.
